FIRE HAZARD

ON HEMTT -A4

MODELS.

PS 691 13 JUN 10

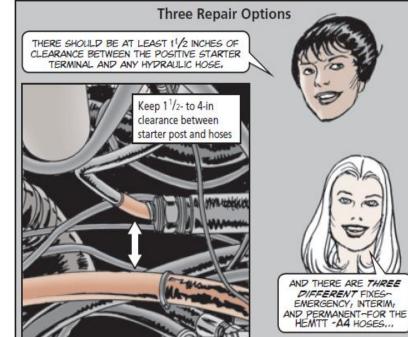
Hydraulic lines rubbing on the positive starter terminal is the root cause of these fires. The outer layer of the hose eventually wears through to the metal reinforcements. That leads to arcing between the starter terminal and the hydraulic line, which sets leaking hydraulic fluid on fire.

1) Emergency fix: This option is only approved for Afghanistan. Just use hose ties to isolate the hydraulic hoses from the starter terminal. Then do the interim fix as soon as possible.

2) Interim fix: For this option, worn hoses shall be replaced before applying the interim fix to the vehicles. A standoff bracket and hose-restraining straps attach the hydraulic lines to the charge air cooler posts. This keeps the lines away from the starter terminals and other electrical connections. Use this method until the permanent fix can be applied.

3) Permanent fix: As parts become available, the contractor will apply this permanent solution for your unit's HEMTT -A4 fleet. They'll lock the hydraulic and electrical routings into a single configuration using pillow blocks and P-clamps to secure the hoses.
